AVOIDING FLASHOVER IN MEDIUM VOLTAGE SWITCHGEAR

By Chuck Humphrey, Highvec Canada Inc.

This article describes some of our experiences over the last 17 years related to damage from corona discharge in 5kv and 15kv indoor/outdoor Metal Clad Switchgear; how we track it down and verifying our findings, using IR Imaging, UV Imaging, Ultrasonic Detection and visual inspection.

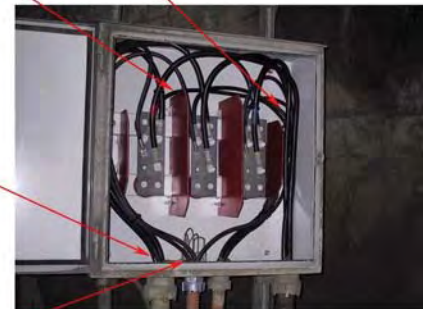
Comments:
Corona is active in JB
We were able to temporarily stop the corona.
A heater should be installed in both Feeder #1 & Feeder #2

Figure 8 shows a 5kv main feeder for an underground mine. No outage was needed for this corona problem. After we cleaned the junction box and separated the leads, a heater was installed to keep the moisture out.

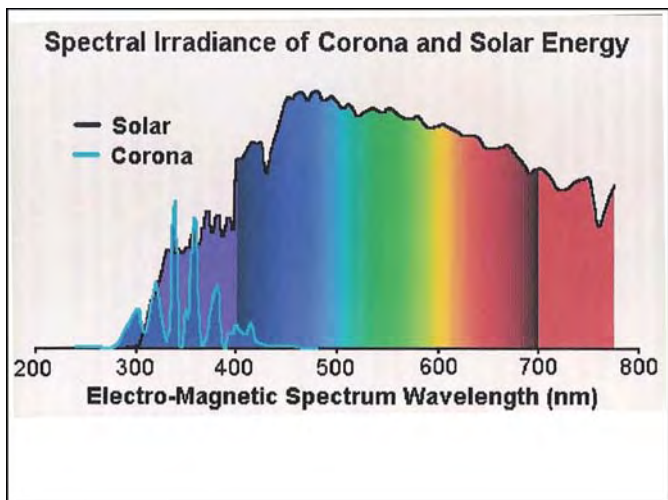
Figure 11

little or no heat, but as it progresses into arcing and tracking, a thermal signature can sometimes be found. Corona is most intense in the 300 to 400 nanometer range in the ultraviolet spectrum. When it exceeds the 400 nm range, corona can be seen in the visual spectrum if there is no interference from background light (Similar to heat coming into the visual spectrum at approximately 585 deg. C. at the 700nm level. As shown in figure 11).

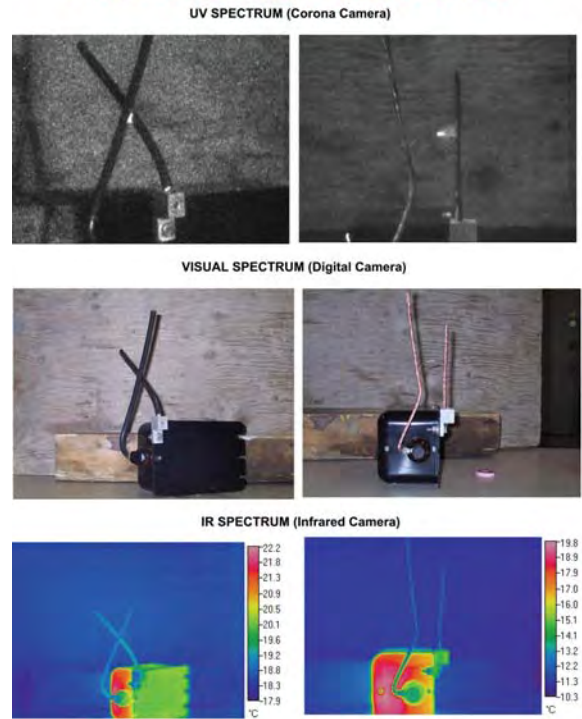
Figure 12

In figure 12 we show two different scenarios of active corona at 5kv. In the left and right columns we see the three different spectrums all at the same time. At the top we have the UV spectrum using the corona camera and corona is evident. In the middle nothing can be seen in the visual spectrum. At the bottom in the IR spectrum using thermal imaging there is no thermal signature where the corona activity is present.
