OPTICAL ARC FLASH PROTECTION AND INSTALLATION EXPERIENCE - PART II

By Robert A. Wilson and Daniel Aronson, ABB Inc.

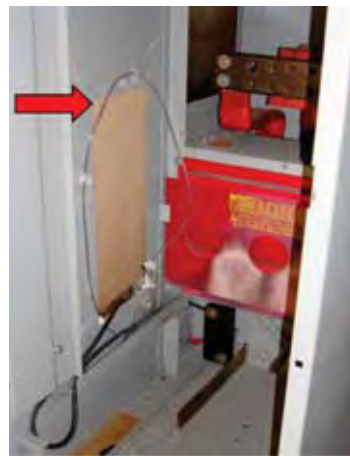
Fig. 6 Optical Fiber Sensor in the Breaker Compartment

The optical fiber sensors in the breaker compartment shown in Figure 6 did not detect sufficient light to operate the optical arc flash relay when the Background Light Reference Level Adjustment was set between midway and maximum for tests 10 through 13 and test 15.

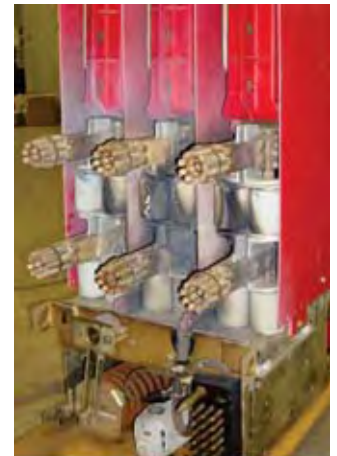
Fig. 7 Failed Westinghouse DHP Breaker

During test 9, the Westinghouse DHP circuit breaker failed to interrupt the test current of 19.7 kA even though its interrupting rating at 4.76 kV is 30.3 kA. The fault was subsequently isolated by an upstream breaker. All optical fiber sensors and all optical lens sensors detected sufficient light and tripped when the Westinghouse breaker failed to interrupt the test current.

Figure 7 shows the external damage to the circuit breaker resulting from the failed 19.7 kA interruption test.

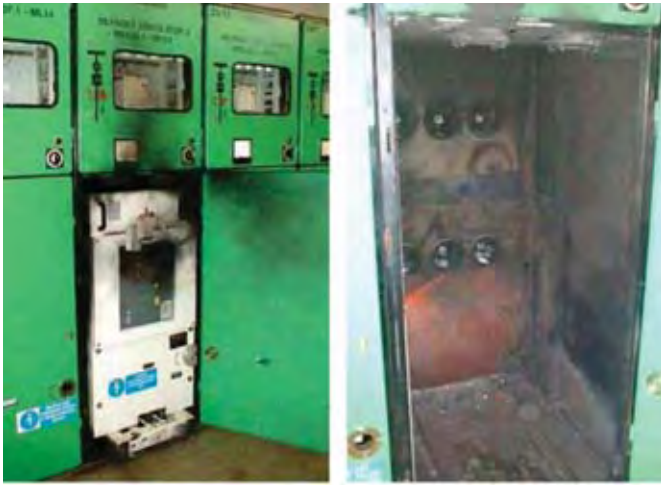
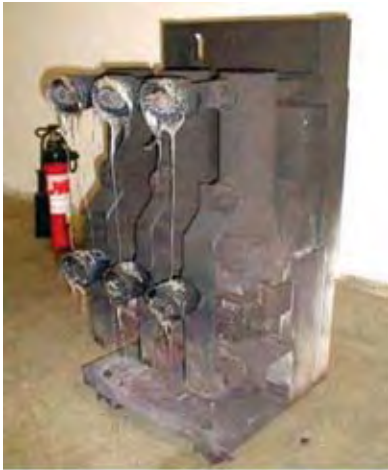
Fig. 8 Detromovice Power Plant 6/26/06 Arc Flash Event Photos

as they tried to rack it into the operation position. To make matters worse, they bypassed the mechanical interlocks as they forced the breaker into position. This initiated an arc that could have caused serious consequences.

Fortunately, the switchgear was equipped with dedicated optical arc flash protection utilizing long fiber sensor technology. Within 82 milliseconds, the entire substation was disconnected and a major personnel and equipment catastrophe was averted.

Eyewitnesses reported that the cubicle compartment was full of white sticky smoke from the burned plastic parts but that was the extent of the damage. Repairs consisted of cleaning the breaker and cubicle as well as replacing the breaker rosette and cubicle pins. Figure 6 shows photos taken immediately following the incident. No permanent damage to the installation or surrounding equipment was encountered and the plant was quickly returned to service thanks to the fast reaction time of the optical arc flash relaying. Most importantly, however, both workers escaped injury and possible death.

Actually, the opposite is true. It is not uncommon for an arc flash event to cascade down a switchgear lineup before the fault can be cleared. The fact that damage was confined to the single cell is remarkable.
