# CABLE CONDITION ASSESSMENT: THE WHOLE PICTURE

By Bruce Neilson, Director, Electrical Technologies, Powertech Labs,  
Kal Abdolall, Senior Research Physicist, Powertech labs

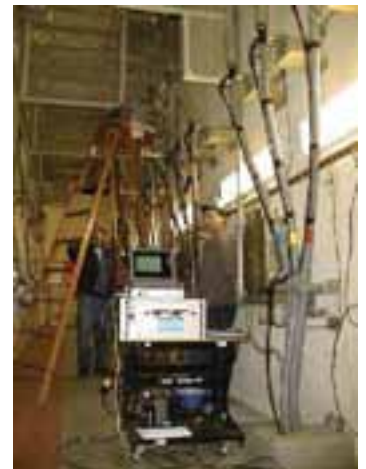
## HOW DOES LIPATEST WORK?

The LIpATEST on-site evaluation method involves applying a negative, step-DC voltage to a cable and measuring the leakage current for one minute at each voltage step. The leakage current is measured with a sensitive, highly filtered, DC pico-ammeter, which is fibre-optically coupled to the data acquisition system.

The test is computer controlled and the test duration is less than 10 minutes per cable. The equipment is suitcase-sized and easily transportable.

Cables with large and extensive water trees (characteristic of aged insulation) show significant departures in the linearity of leakage current vs. test voltage. AC breakdown voltage tests on these cables yield low breakdown voltages, confirming the effectiveness of LIpATEST.
