ELECTRICAL WIRING PROBLEMS AND CODE VIOLATIONS

PLUMBING CURRENT MAGNETIC FIELDS EMF FROM WATER PIPES

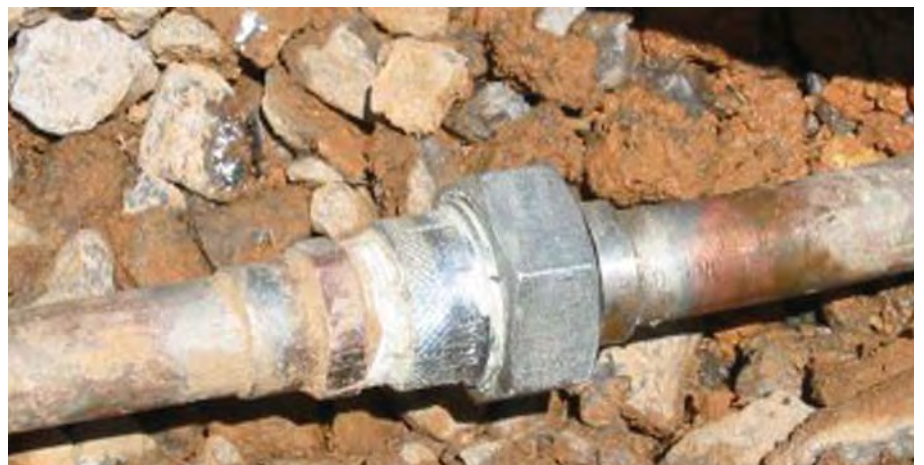
One type of dielectric coupler (union) installed in water line.

This undesired current flow can be blocked very effectively, and in a manner that is code compliant, by the installation of a dielectric coupler, or insulating coupling, in the water supply line to the building. Several strong cautions are necessary before this work is planned.
